# Manhole Inspection Summary

Manhole # S35AA1017MH

Insp Date: **3/28/07 10:28 AM**

**Location** Address: **3421 GUILFORD TERR**

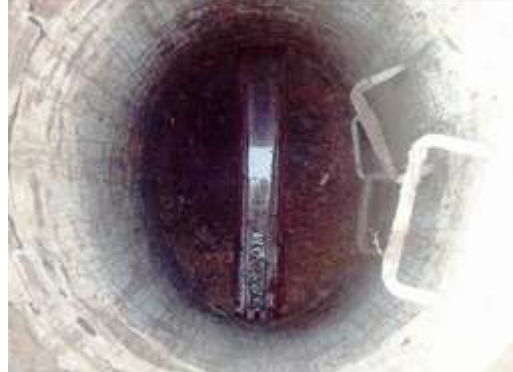
Top View

Corroded steps. Evidence of surcharge - Bench debris.

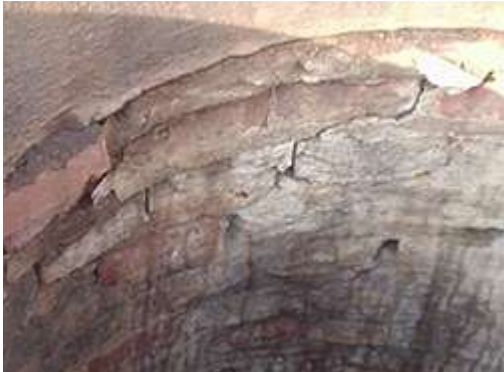
Defect

Frame leaks. Adjustment and Corbel deterioration and infiltration - other side.

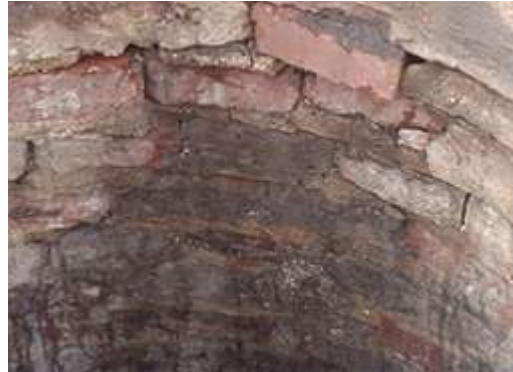
Defect

Frame leaks. Adjustment and Corbel deterioration and infiltration.

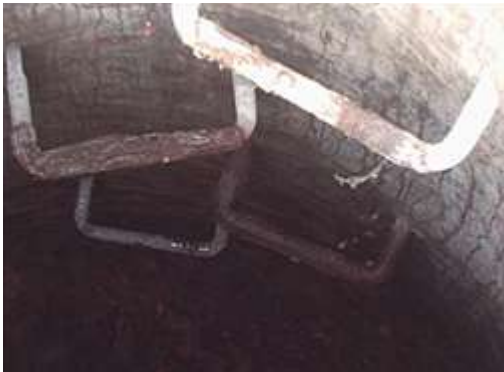
Defect

Barrel infiltration. Corroded steps.

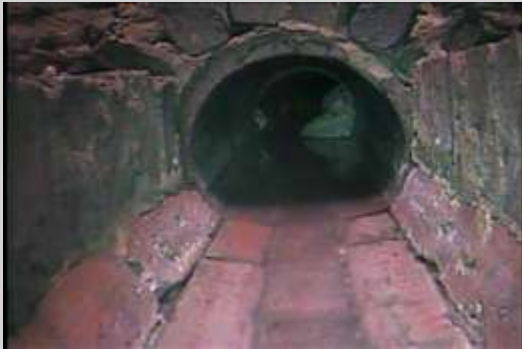
### 8 in. Circular Gravity Sewer Pipe Out @ 12 O'Clock

Channel deterioration.

Infiltration: **Evidence** Pipe Seal Cond: **Cracked**
